To be presented at: **V SEPOPE**  
Recife, Brasil  
19 May, 1996

## ITAIPU HVDC TRANSMISSION SYSTEM 10 YEARS OPERATIONAL EXPERIENCE

**FURNAS Centrais Elétricas**

**ABB Power Systems**

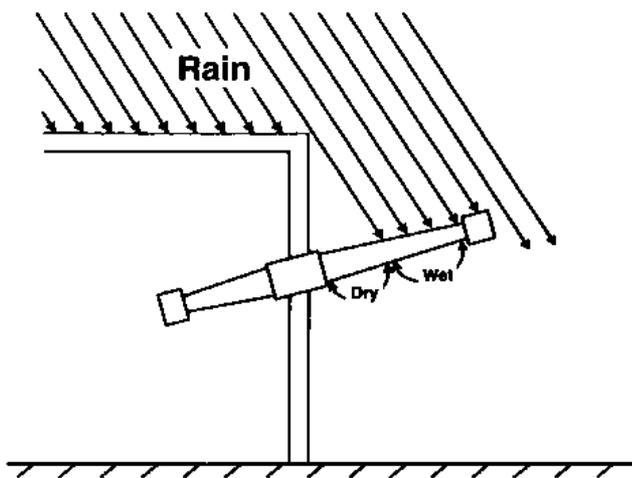
By the end of the year, a total of five flashovers had occurred at Foz do Iguaçu and two flashovers at Ibiúna, on both the positive and negative poles for five different bushings, all under heavy rain conditions. By that time it had become clear that this was a general problem for the 600 kV wall bushings

It was confirmed that a rain shadow close to the wall decreased the withstand voltage considerably, see figure 5, and that the length of the dry zone was an important parameter for withstand strength. A minimum withstand dry zone could be found and figures as low as 350 kV were recorded. Observations at site established that a rain shadow gave a dry zone on the bushings close to the wall. Later electrical field measurements confirmed that a dry zone causes a steep increase in the electric field and that this is the cause of the flashover.

Figure 5. Rain shadow

From the investigations it became evident that it was necessary to either decrease the stresses over the dry zone or increase its withstand capability. The most promising method seemed to be to make the insulator surface non-wetting and thereby decrease the steep electrical field increase in the transition between the wet and dry zones. This could be made by application of a hydrophobic coating on the insulator surface by silicone grease or room temperature vulcanized silicone rubber (RTV).

In June 1986 silicone grease was applied to all 600 kV wall bushings as a temporary measure while the investigations continued. Evaluation was made of coated insulators, both compared to other possible countermeasures and also between RTV and silicone grease. No conclusive improvements could be found from other measures such as alternative porcelains or booster sheds. Both RTV and silicone grease seemed to give considerable improvements and the experiences from the temporary silicon grease application was excellent, preventing further

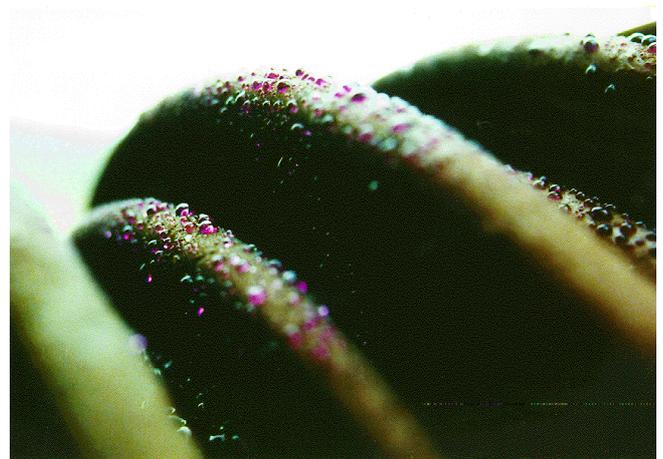
RTV had shown good performance in other installations and had indicated longer life-times than silicone grease, but application is more difficult and it is uncertain if it can be removed easily. During an investigation on test specimens on site, RTV exhibited an unexpectedly rapid loss of its hydrophobic properties. This was followed up by laboratory experiment that showed that if exposed to water over a long time, RTV would lose its hydrophobicity. Thus it seems that RTV may not be efficient in tropical climates with heavy and abundant rain. The conclusions were that silicone grease of the type chosen could most probably get a lifetime of 4 to 5 years in a clean ambient atmosphere and that thickness and evenness were not a problem. Even a fairly thin layer would protect the hydrophobicity and thereby prevent rain flashovers. This was confirmed by an on site test program for various types of silicone grease and RTV, including application to energised test insulators at 600 kV. On the wall bushings the time between exchanges was increased, for the original grease type, under close supervision of characteristics, especially hydrophobicity, see figure 6.

Figure 6. Foz do Iguazu 600 kV wall bushing. Hydrophobicity test on silicone grease after 38 months exposure time.

Actual experience has shown that removal and reapplication can be considerably facilitated by control of the chemical composition and the use of simple hand tools that were developed. Now, with more than nine years successful use of silicone grease, the procedures developed have led to fast and well controlled grease renewal. A minimum four-year lifetime is proven by operation experience for the conditions prevailing at the Itaipu converter stations.
